## IBX CUSTOMER POST INCIDENT REPORT

Summary of Report Information & Notification	
Maintenance Report Reference / Trouble Ticket	5-200099225799
Date of Incident / Report	August 18 <sup>th</sup> 2020 / August 19 <sup>th</sup> 2020
Report Prepared By	Lee Robinson
Report Type	Final
Report Recipient/s

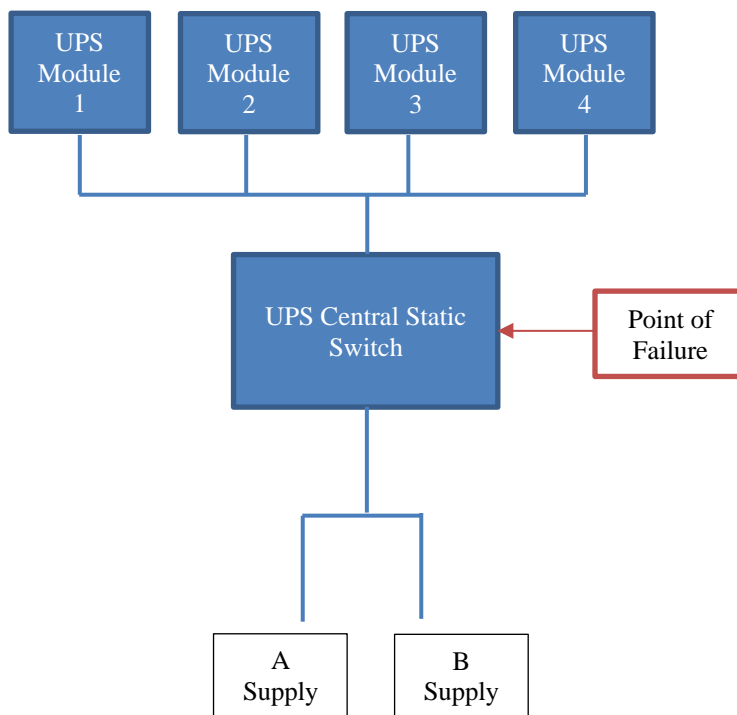
## Old UPS System

An unrepairable failure to the Galaxy UPS Static transfer switch common output cabinet and associated switchgear. This was a known single point of failure on the legacy N+1 UPS infrastructure.

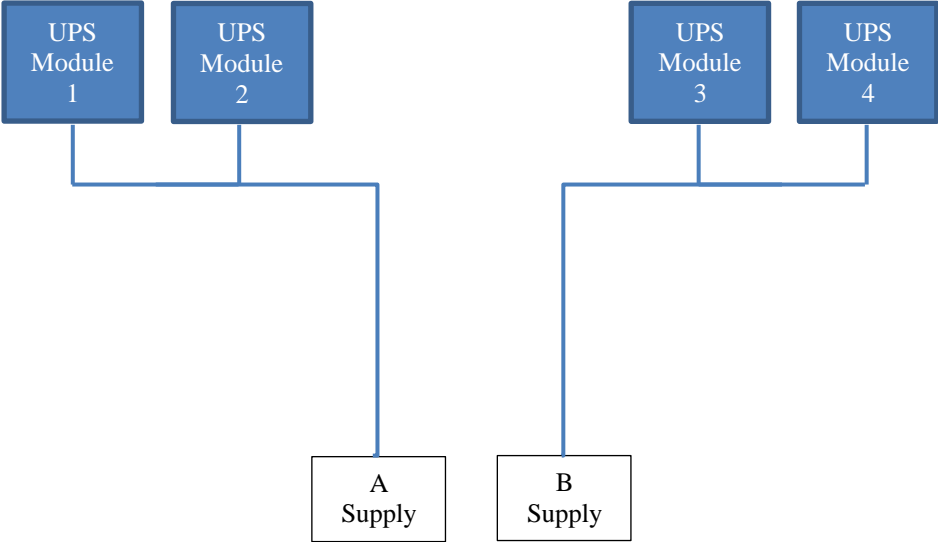
New UPS System

This new UPS infrastructure gives customers dual independent power distribution from the UPS to cabinets.

As part of an ongoing project to migrate away from the Galaxy UPS system, Equinix had previously installed and commissioned new electrical infrastructure. The UPS topology now supporting customer equipment is a fully diverse and redundant arrangement with no single point of failure between UPS and customer equipment.
